Reconnaissance Survey
of the
Historic
Chenango Canal

Within the Boundaries of Broome County

Conducted by
Cynthia Carrington Carter
April – August
2007

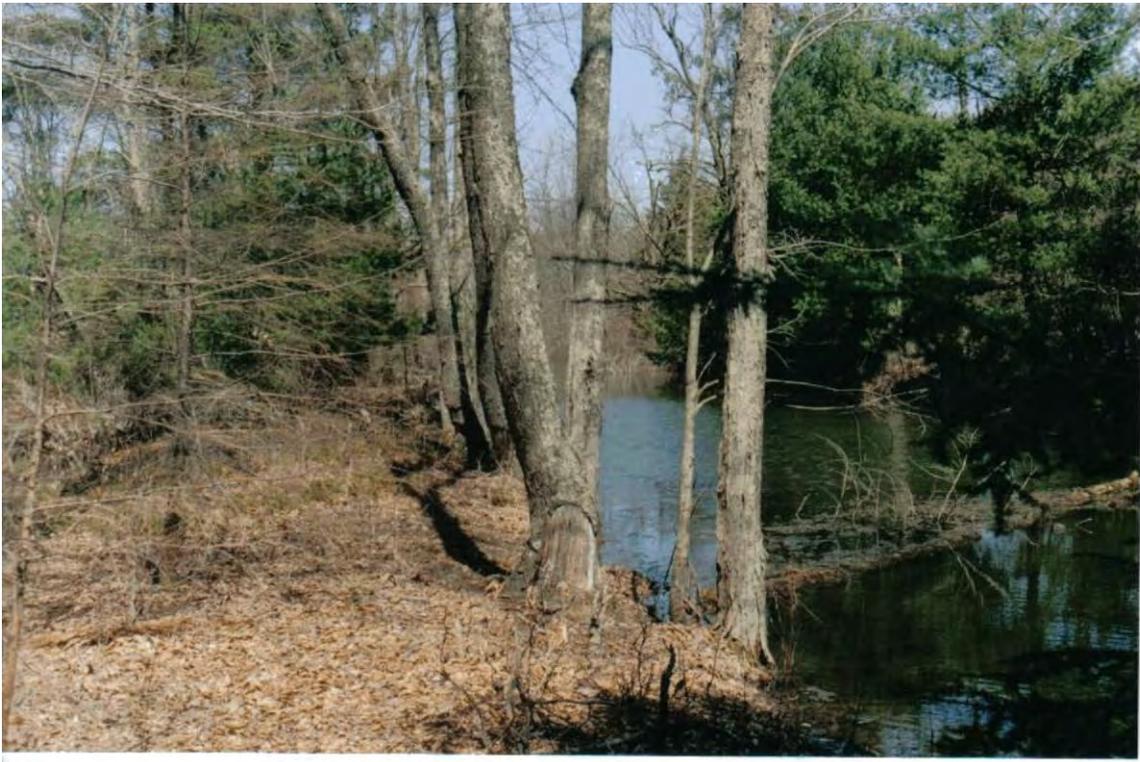
Looking north along the tow path into Chenango County.
Trees and brush are growing on the tow path. Water fills the prism.

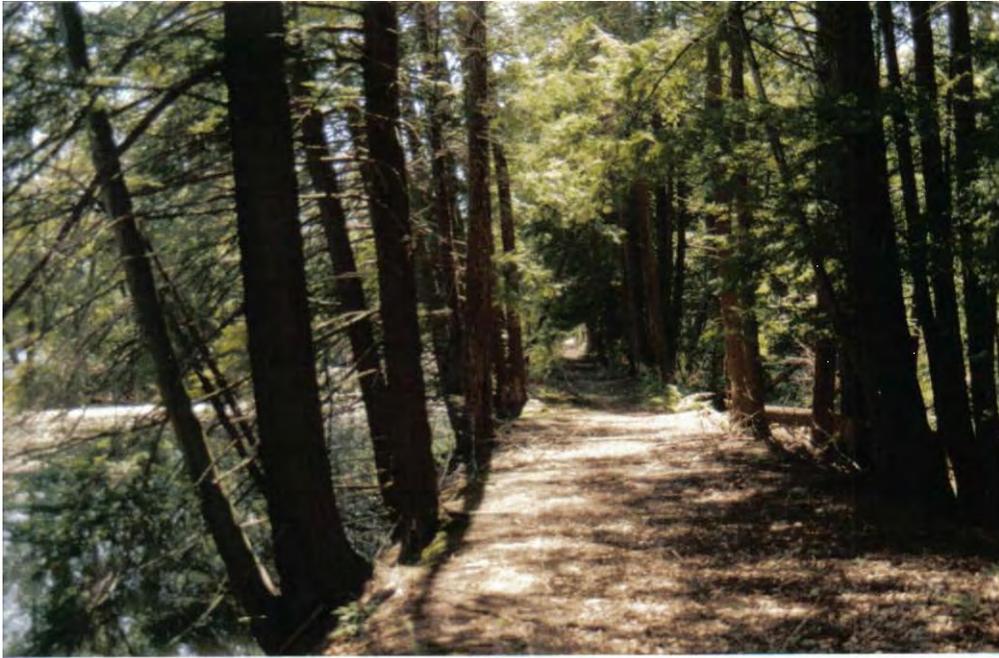
057.04-1-3.112

Looking south along the tow path from the property line

The canal is well preserved as it passes through the woodlands and farm fields of this 43 acre farm. The property owner maintains the tow path as a farm road.

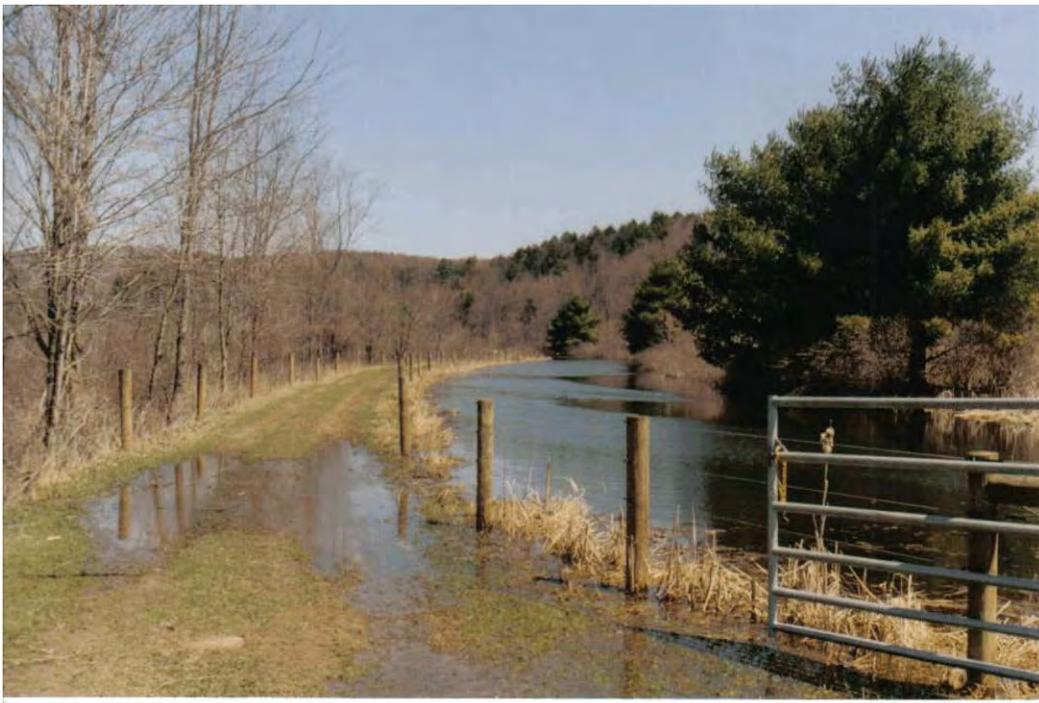
Looking north from the pasture gate

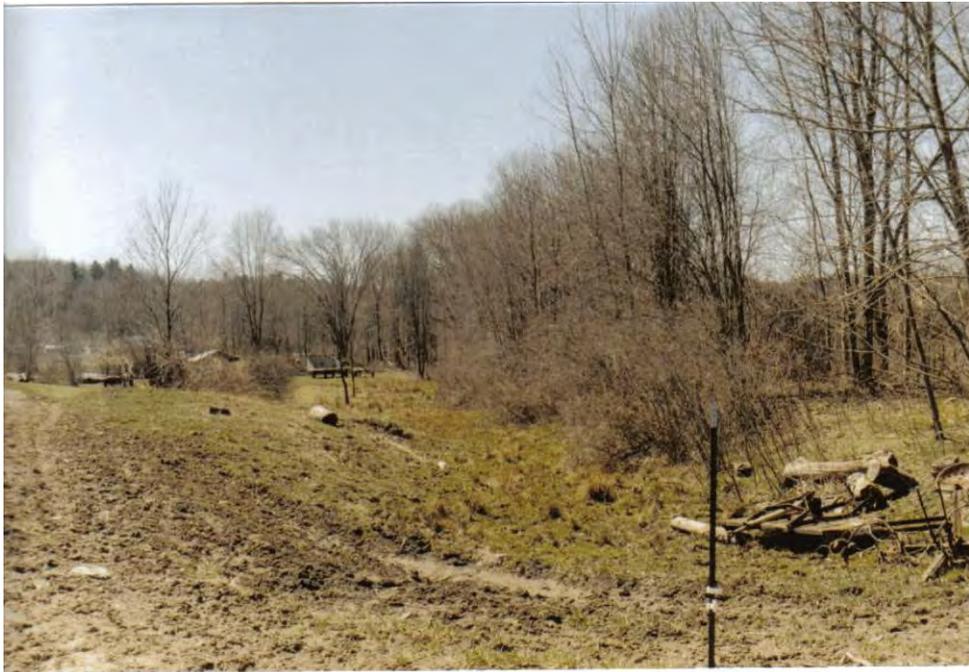
Behind the barn the canal prism has been dammed and the prism is dry to the south

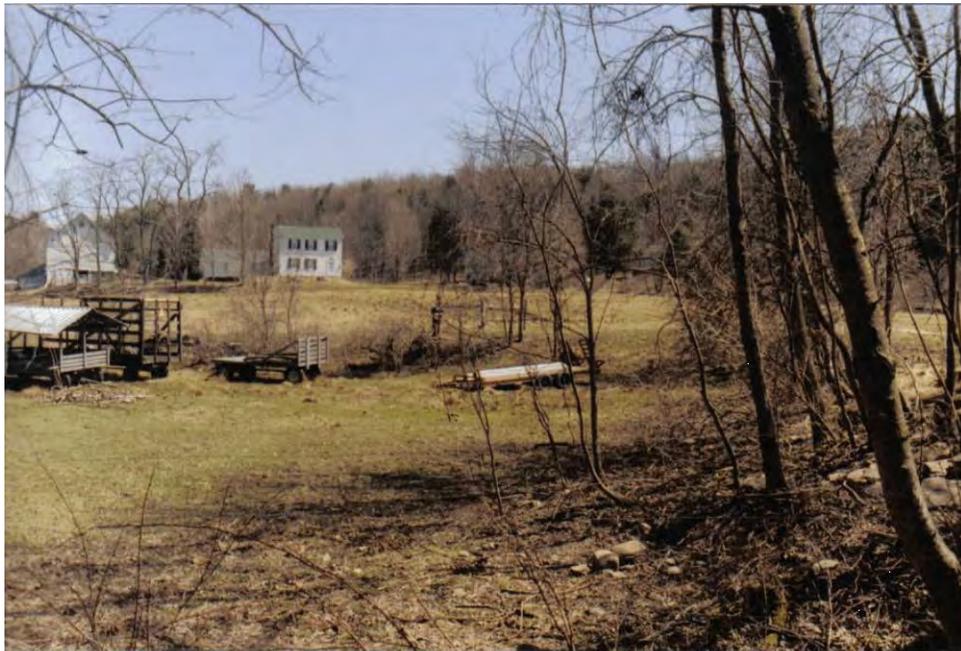
Lock 106 is located in a pasture near the farm's west property line. The outline of the wide waters located on the north side of the canal is clearly visible from the lock. The farmhouse located on the knoll above the lock dates from the period of the construction of the canal.

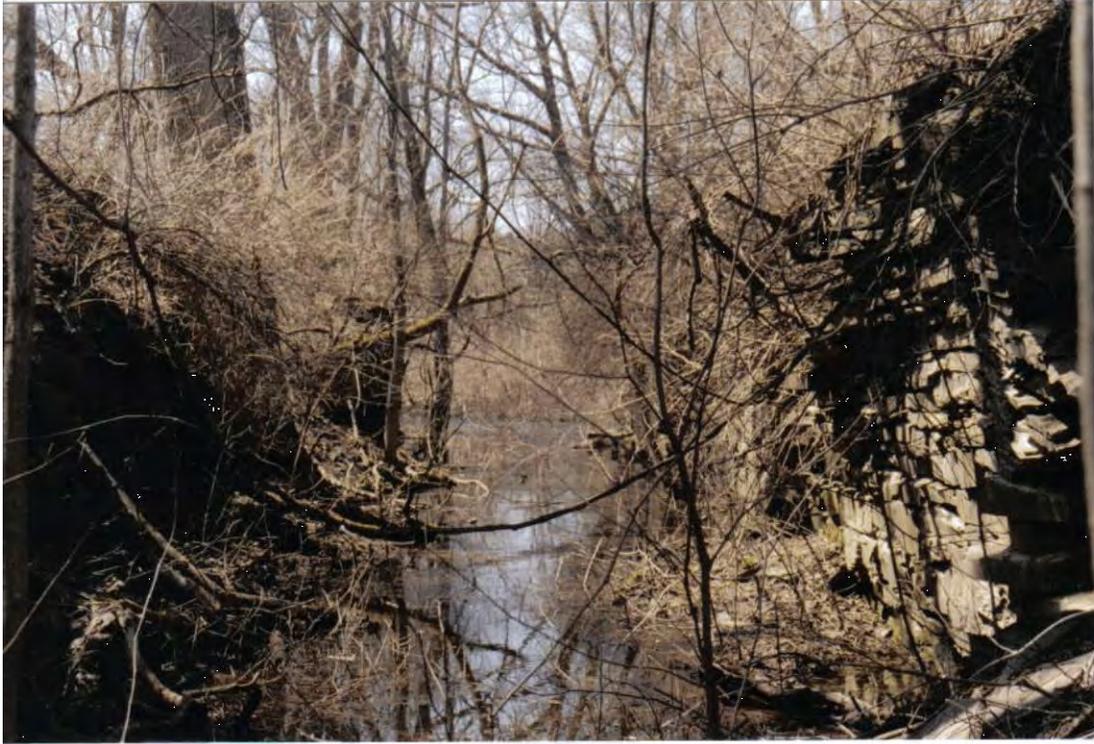
Looking south from the north end of Lock 106

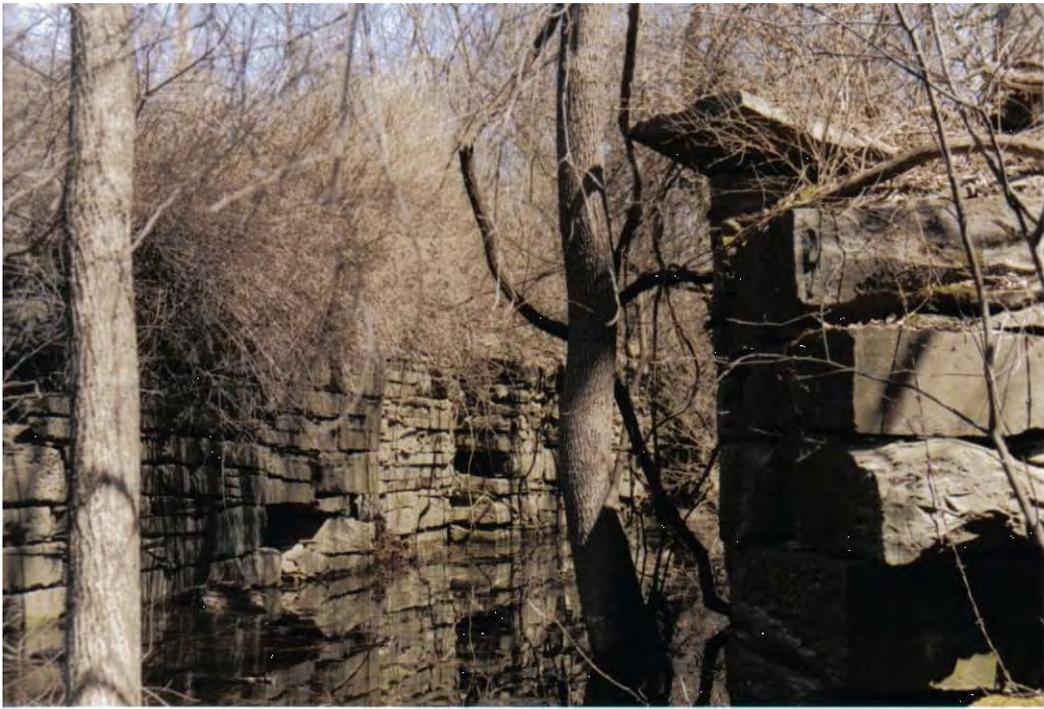
Looking at the west wall of Lock 106 from the south end.

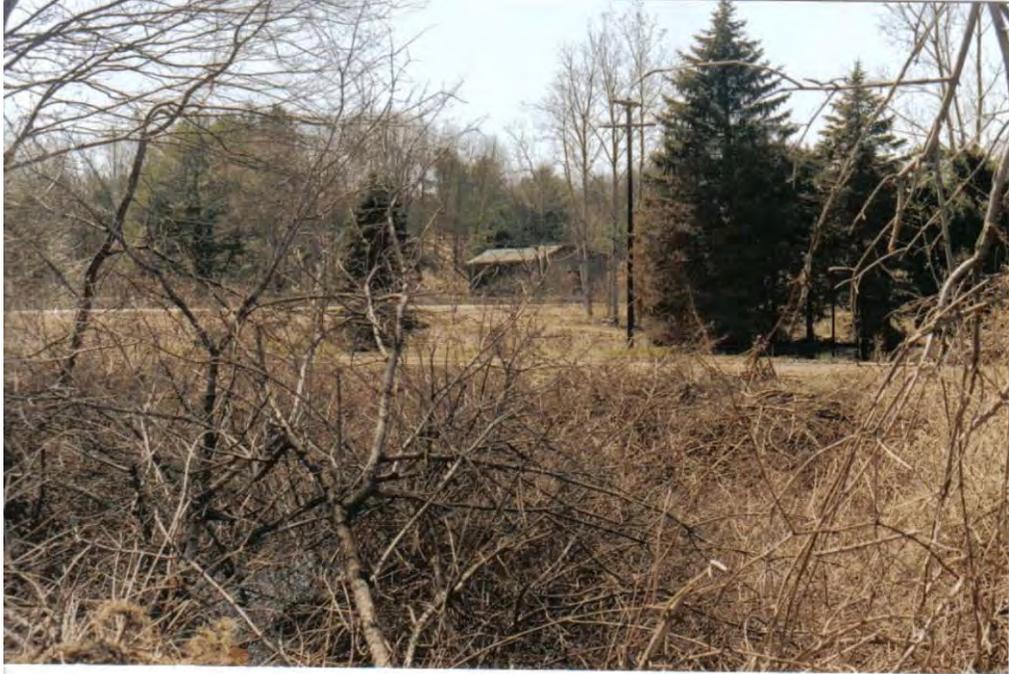
Looking south across the prism choked with brush.

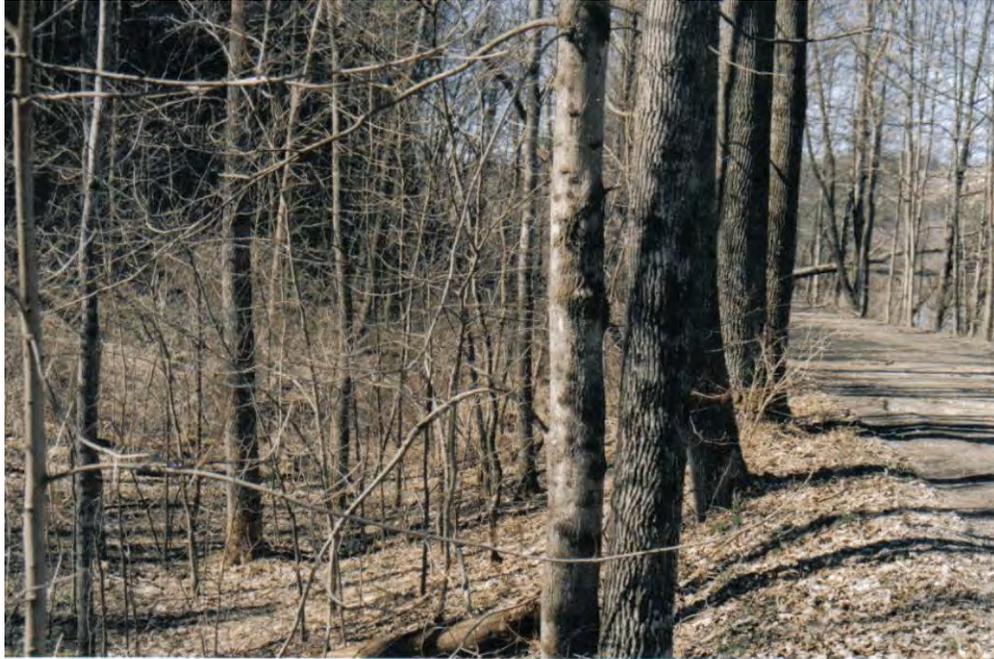
The canal hugs the base of the hill and the tow path follows the curve of the river.
The canal prism is overgrown but intact. The tow path is now River Road.

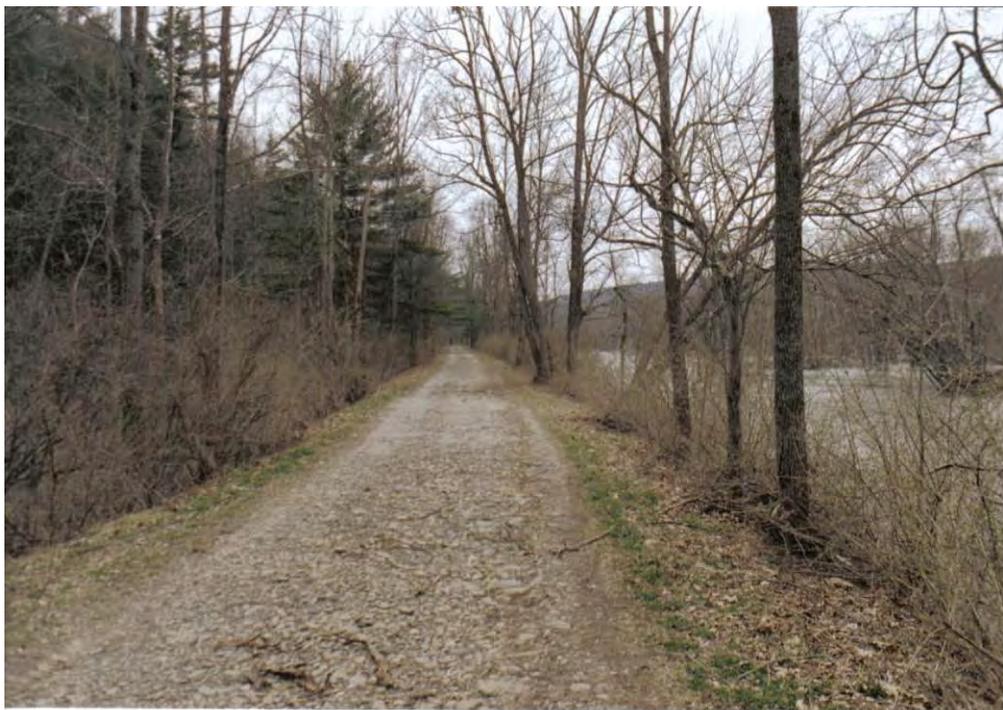
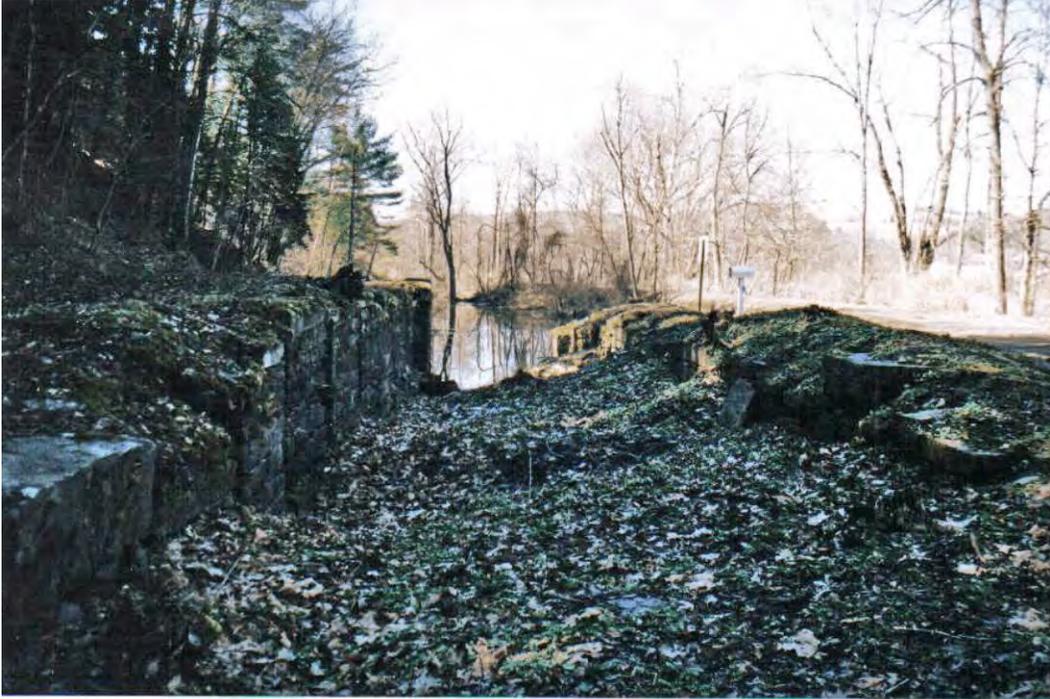
057.17 - 1 - 3

Remains of Lock 107 and the guard lock are located on this property, which is owned by the People of New York State. At its north end much of the lock has been filled and stone was scavenged from the west wall for a foundation. The east wall is well preserved. At the south end it is open and there is standing water in the lock.

Above, looking into the canal from the north end. Below, looking into the canal from the south.

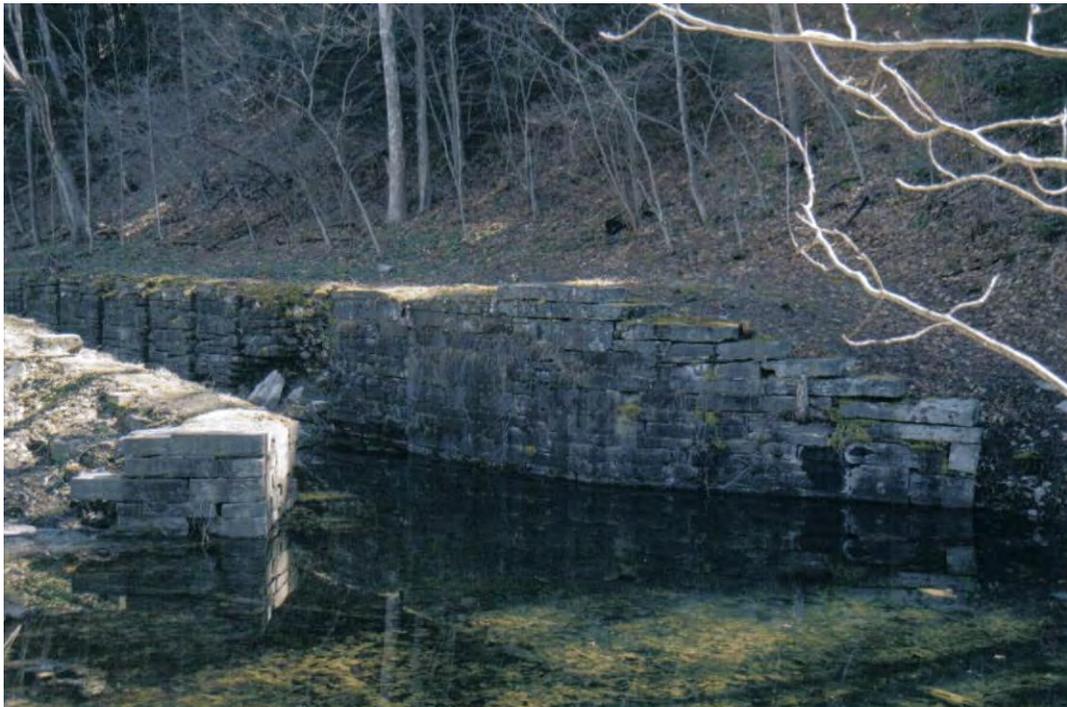
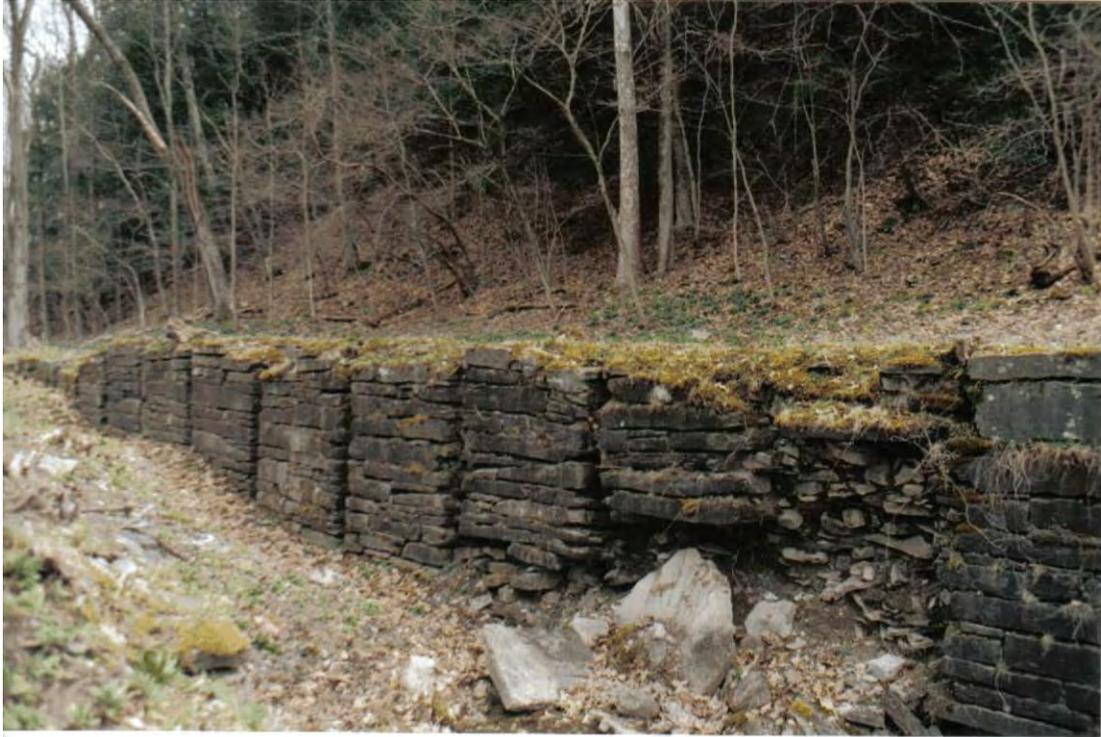
Above - east wall. Below - west wall at the south end of the lock

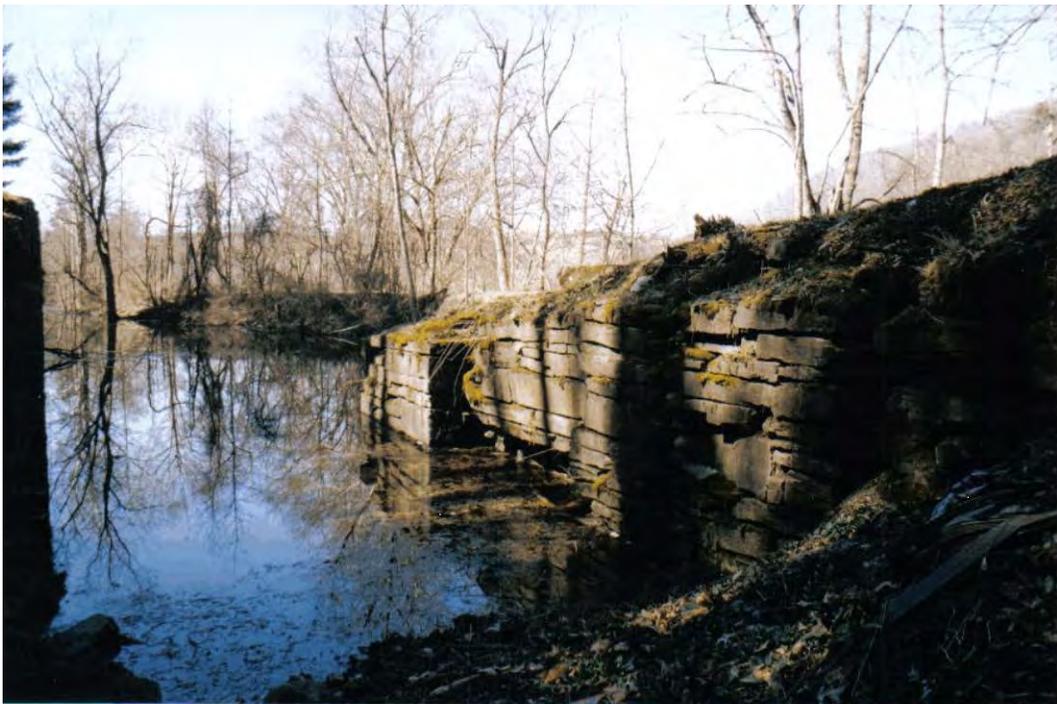
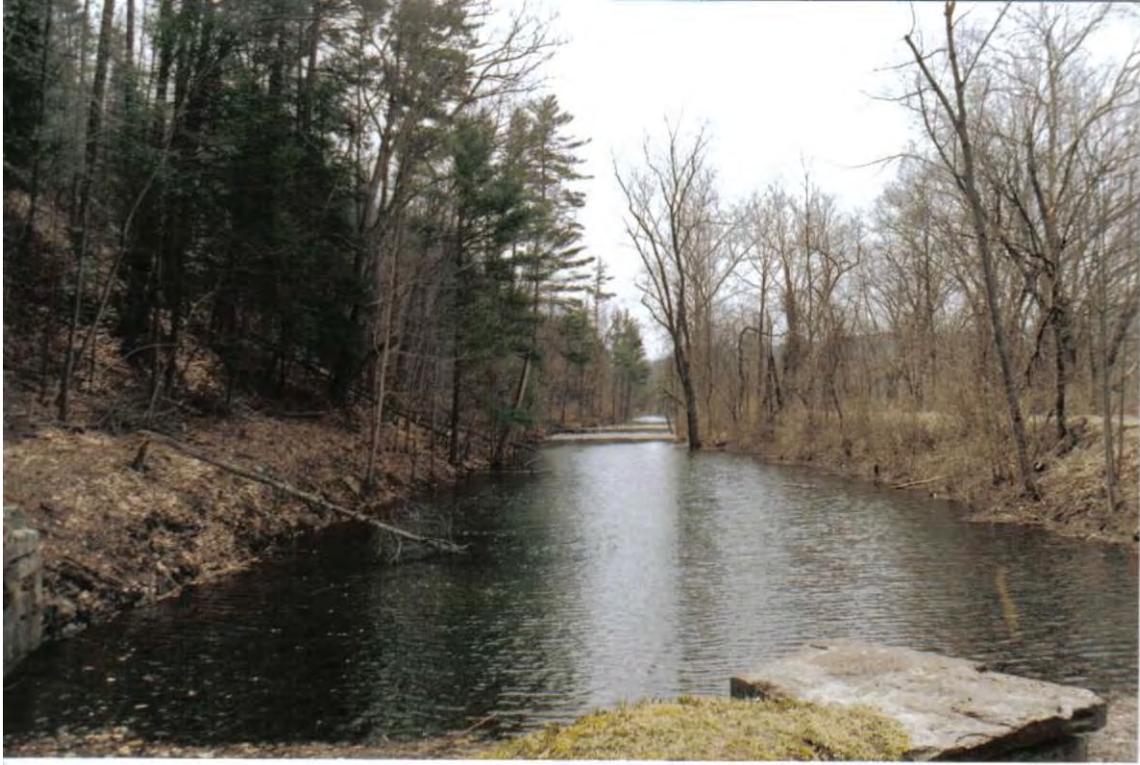
Above - looking south down the water filled prism from the west wing wall of Lock 107.
Below - remains of the guard lock which allowed water from the river to feed the canal .

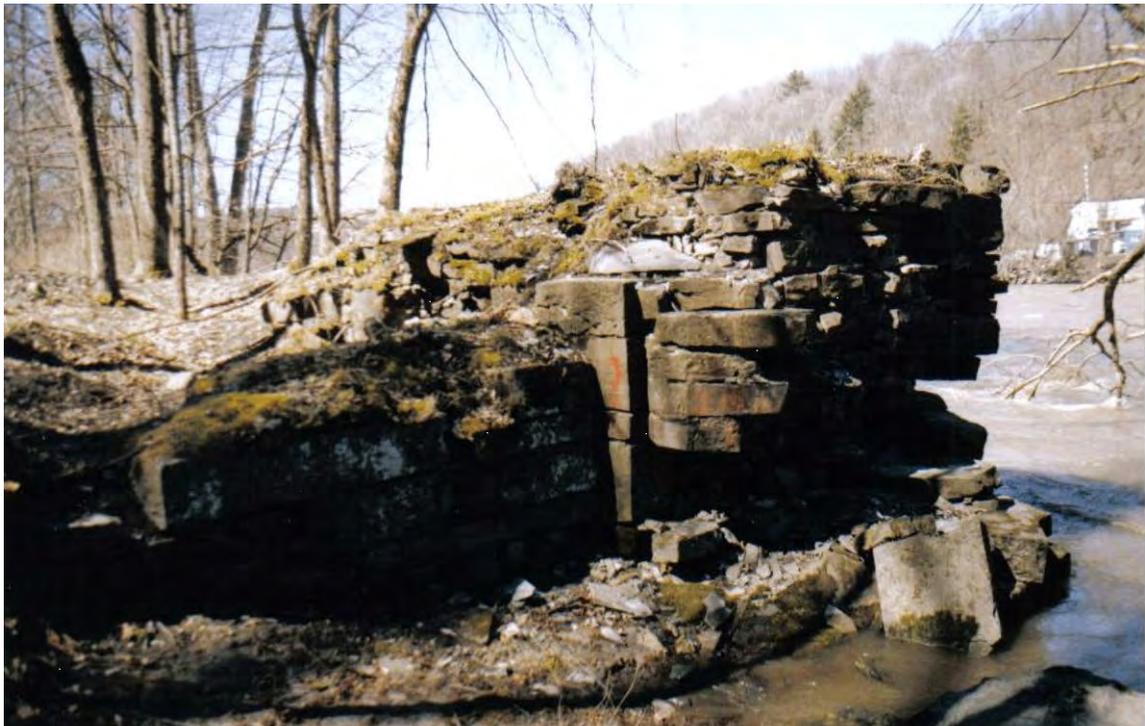
There was a state dam in the Chenango River adjacent to Lock 107. Water from the river could be diverted into the canal as needed by the guard lock. This feeder entered the canal just south of Lock 107. Remnants of the dam are visible on the east bank of the river from NYS Route 79 on the west bank. Only a few laid up stones remain on the west bank.

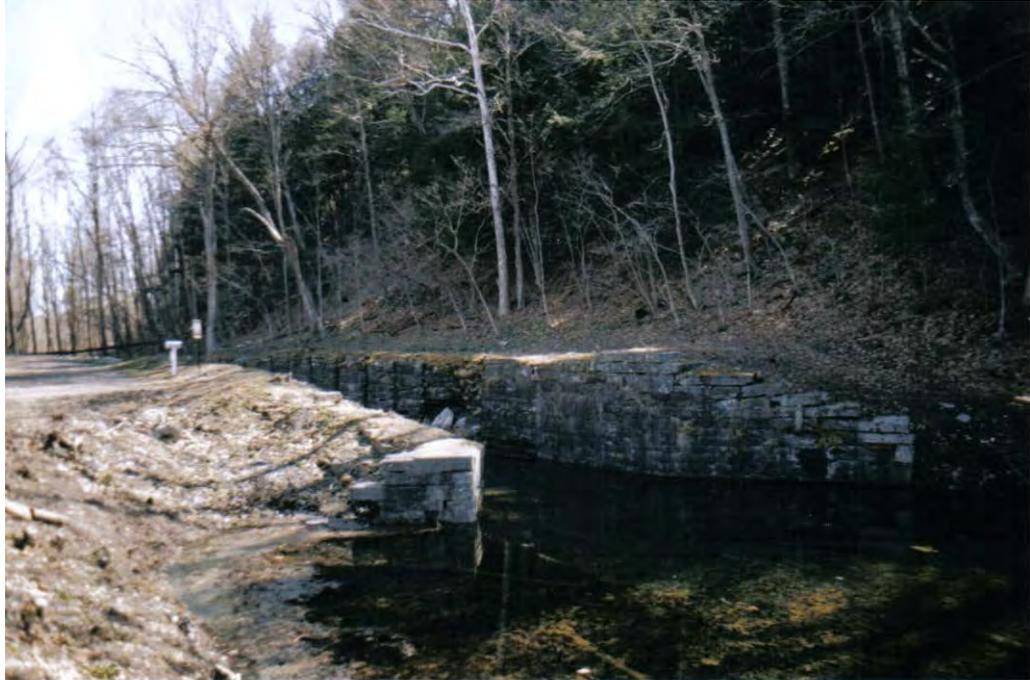
Water from the Chenango River entered the canal here, just south of Lock 107.

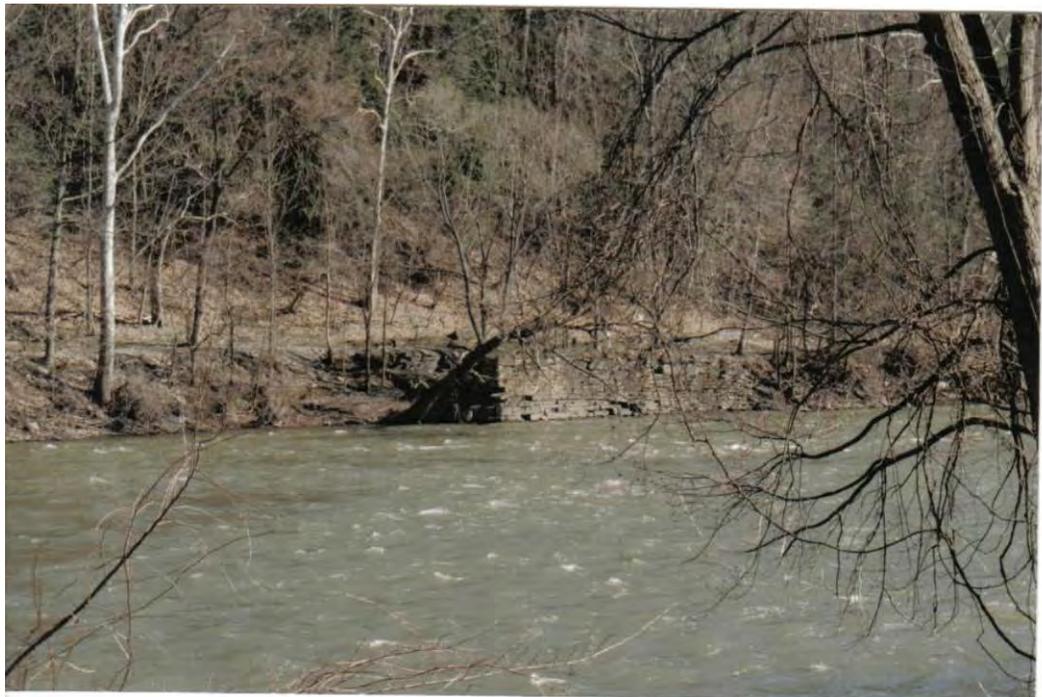
The guard lock seen from the west bank of the Chenango River.

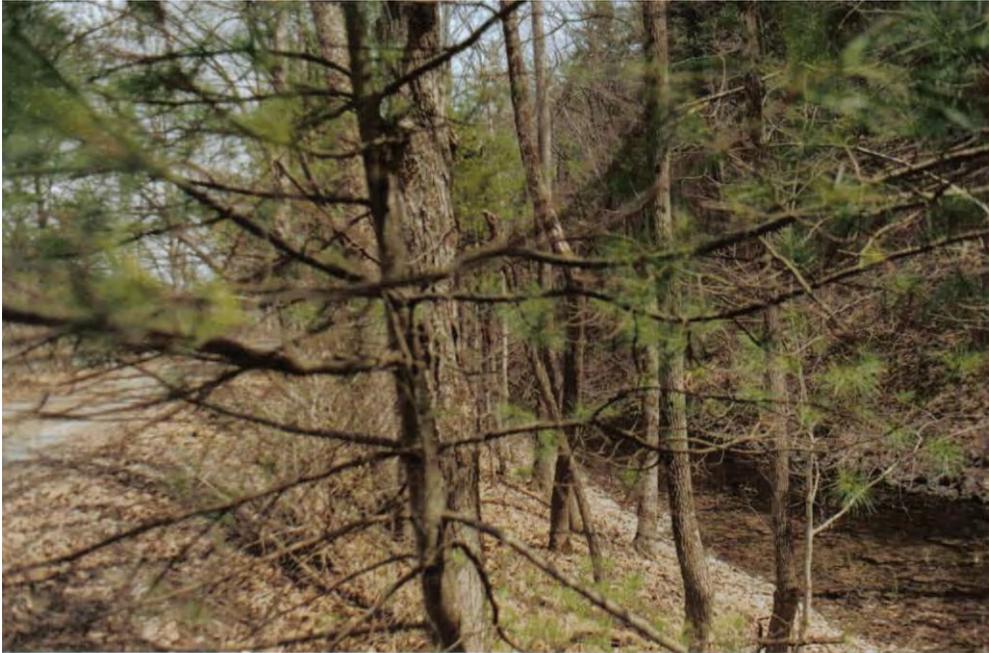
Less water is retained in the canal and small trees are growing within the prism.

Looking north, the tow path is on the left.

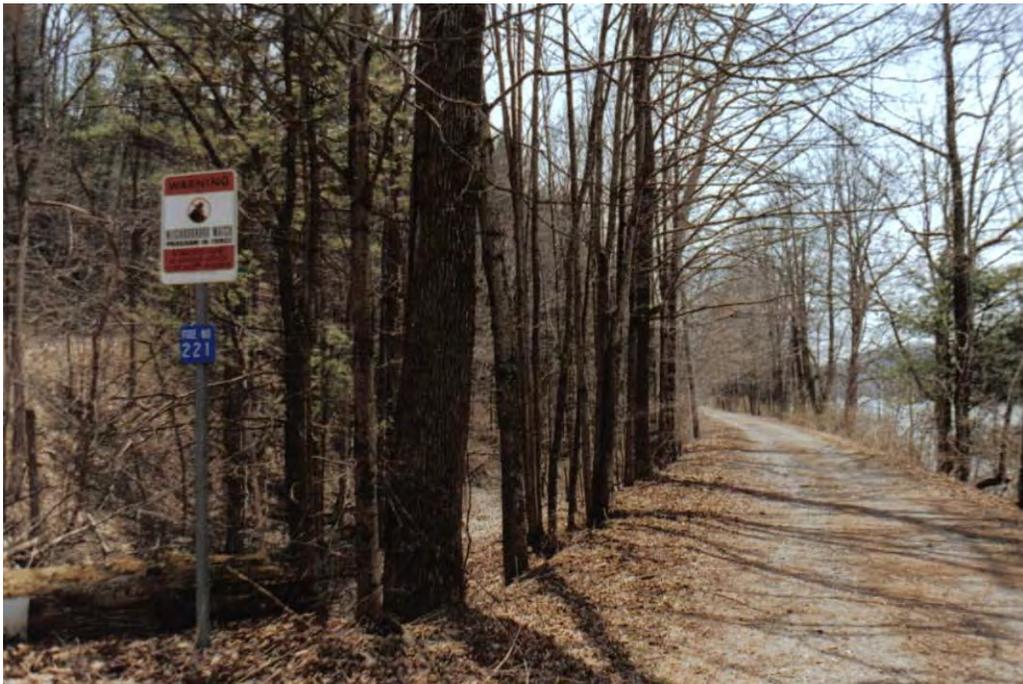
Looking south, the prism is no longer filled with water, and brush is growing in the canal.

Looking south along the tow path the prism is on the left, the river is on the right.

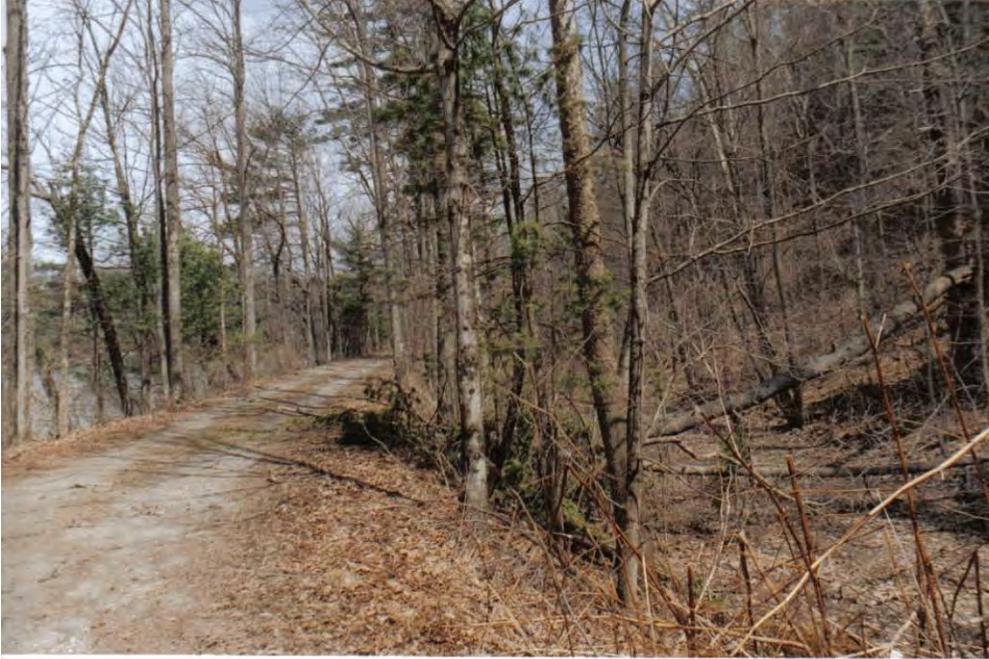
River Road comes to a dead end at this property. The prism is intact, but dry.

Looking north

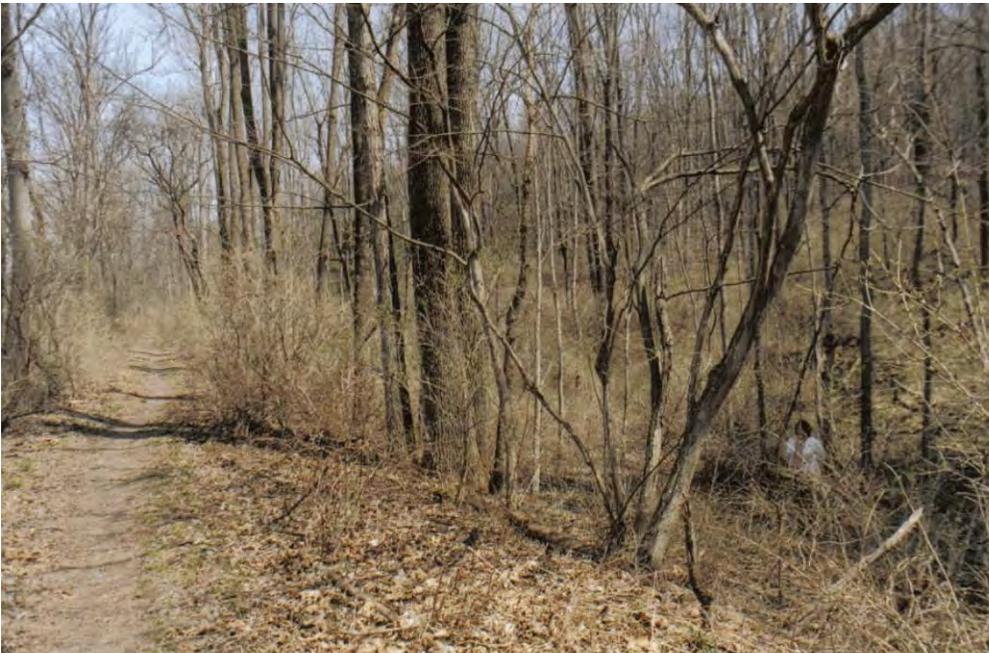
Once River Road comes to a dead end, the tow path becomes choked with brush with only a narrow path cut through it. The prism loses definition as it, too, becomes choked with brush.

Looking north,
the tow path is
on the left. On
the right, a
person is
standing in the
prism.

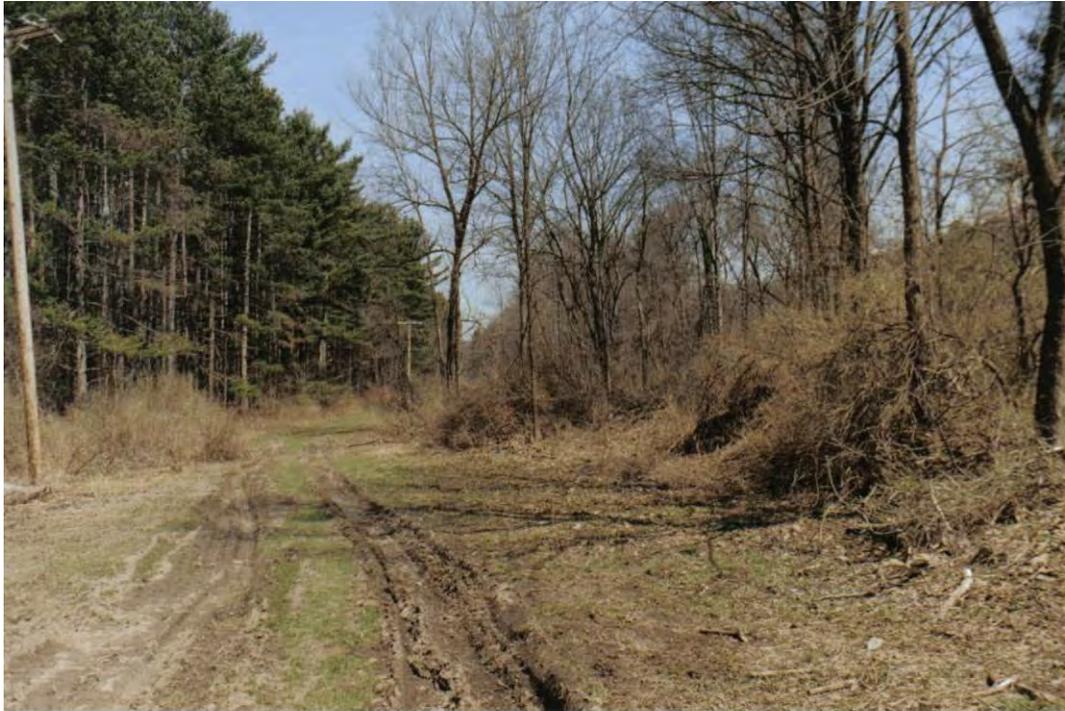
For a short distance, the prism has been filled and there is no trace of the canal. However, within a few hundred feet, the prism is again visible, although there are trees growing in it. The tow path is a well maintained service road.

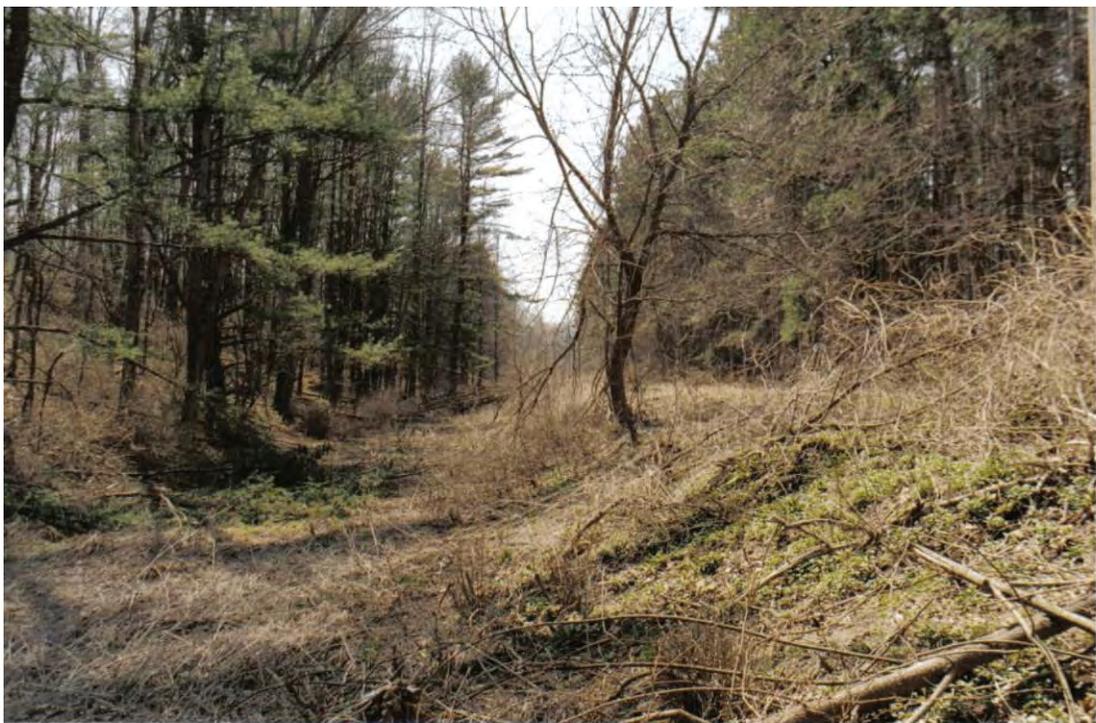
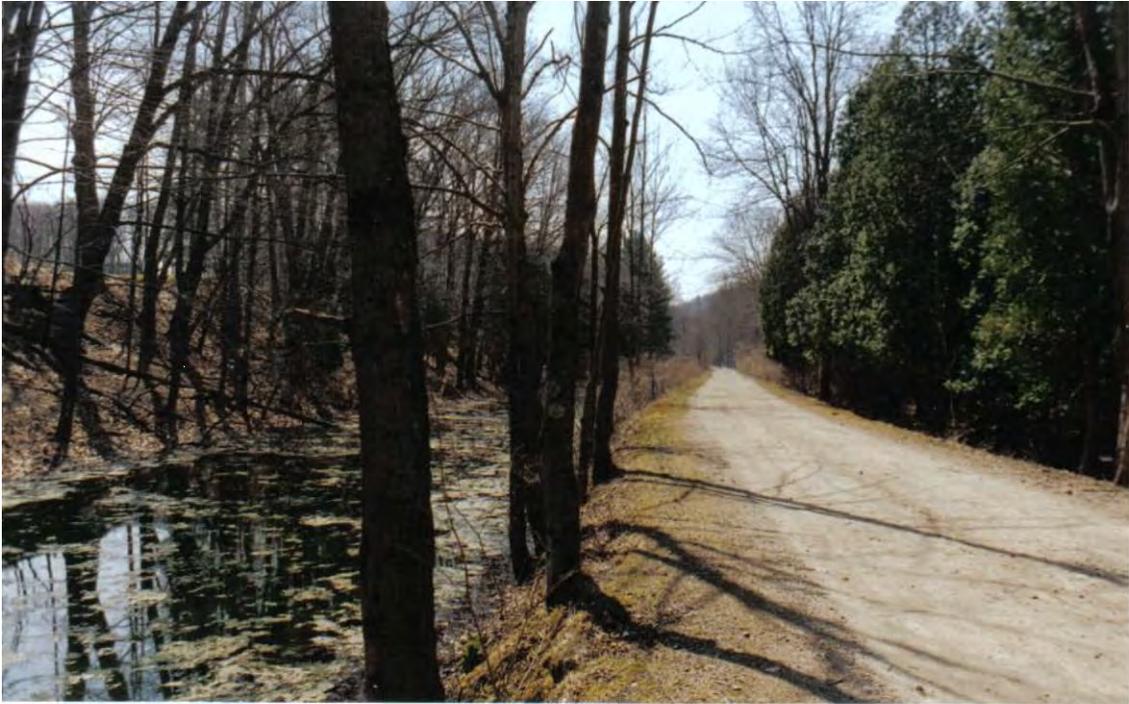
Continuing south in the area of the golf course, the prism is again filled with water.

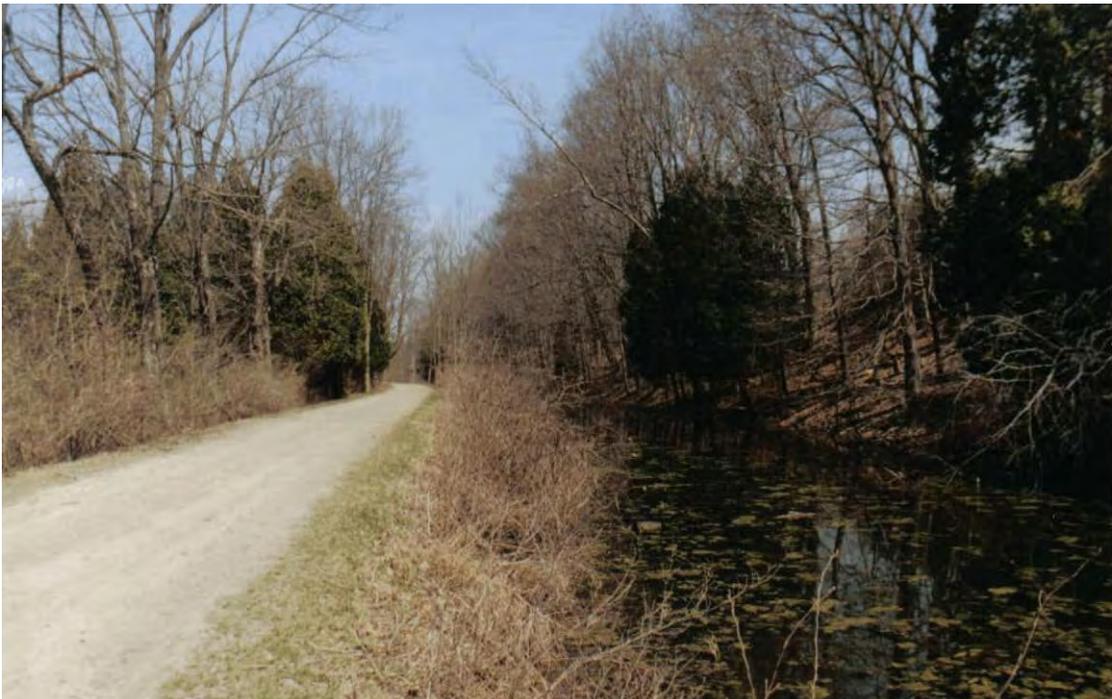
Looking north along the canal.

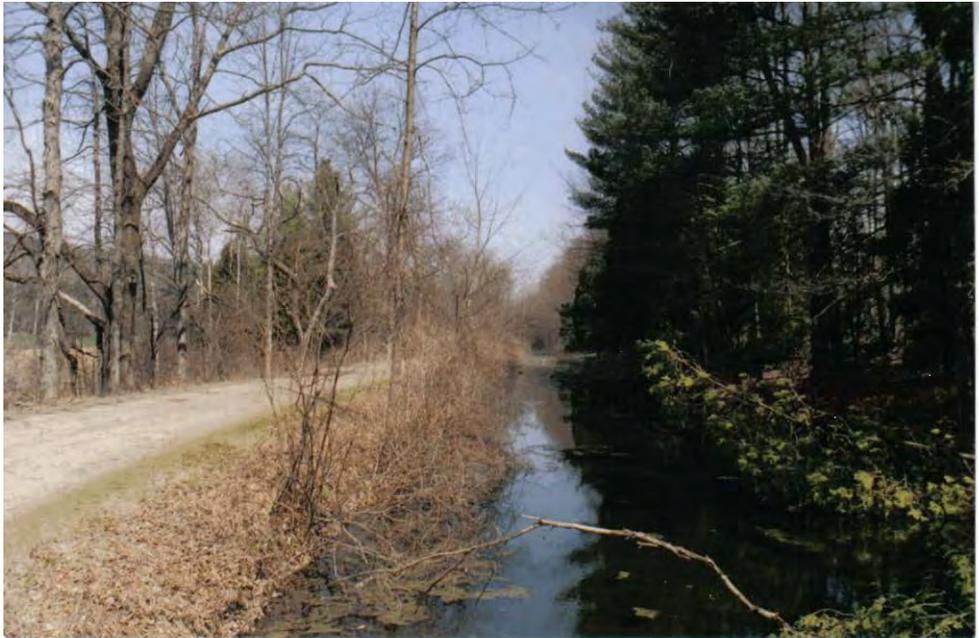
Looking north along the canal within Chenango Valley State Park,
in the area of the Chenango Valley Golf Course

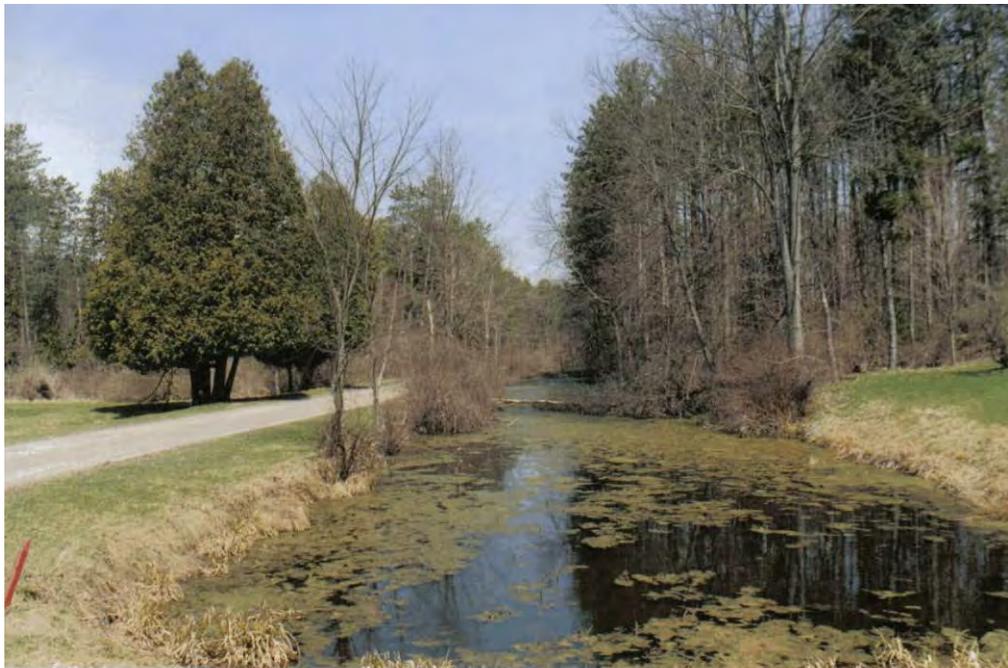
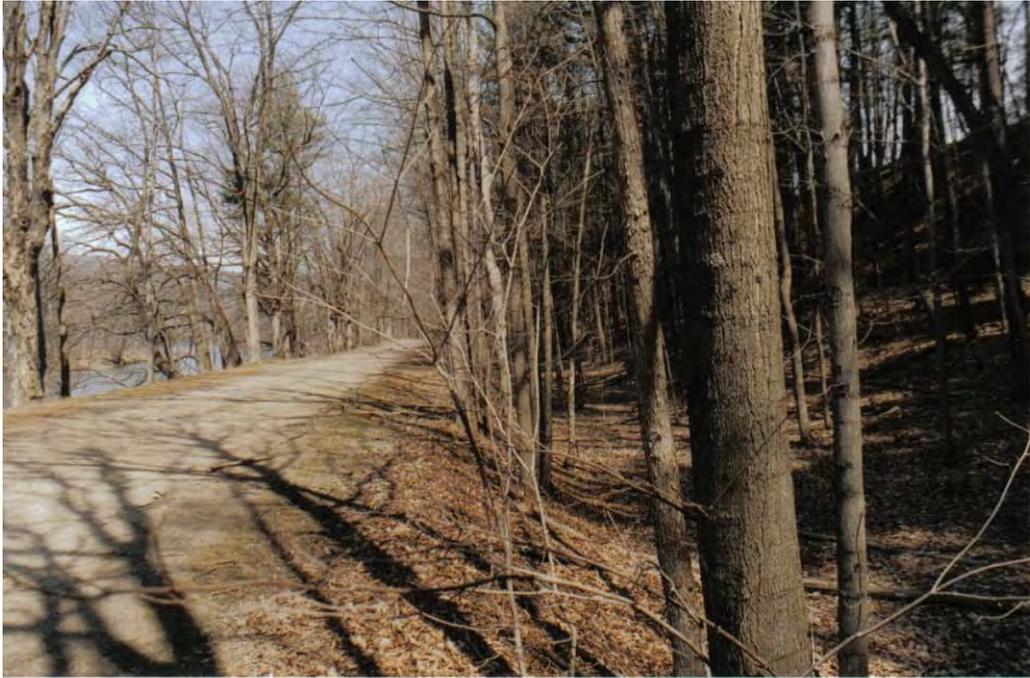
South of the golf course, the canal is again dry and trees are growing in the prism.

Above - looking north. Below - looking south toward the main parking lot.
