Reconnaissance Survey
of the
Historic
Chenango Canal

Within the Boundaries of Broome County

Conducted by
Cynthia Carrington Carter
April – August
2007

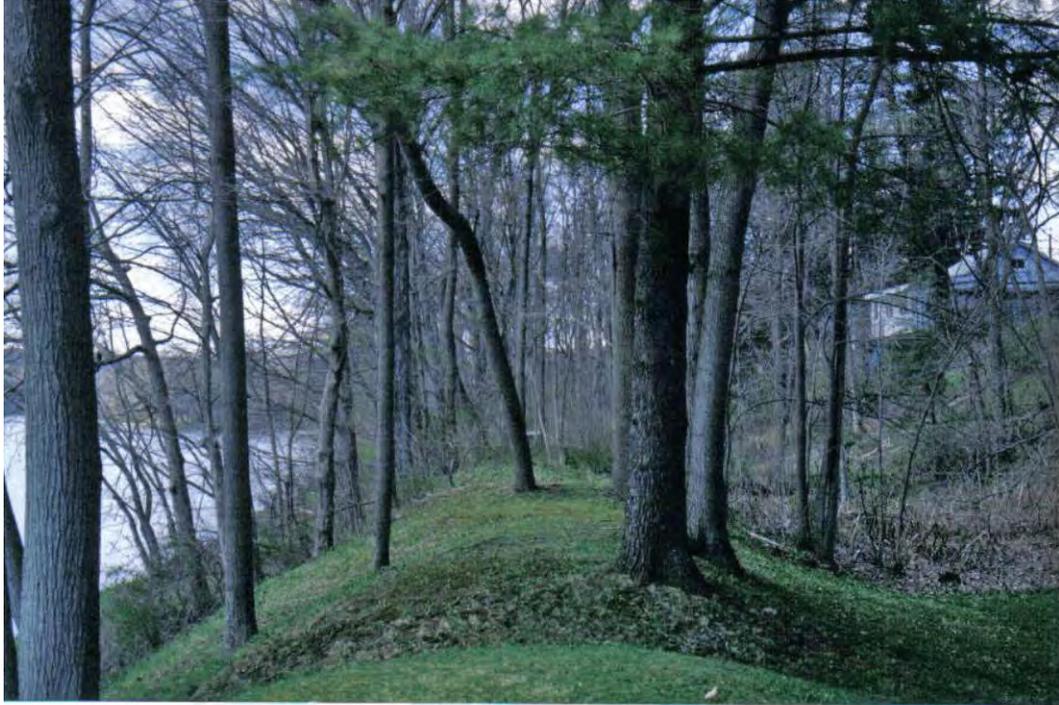
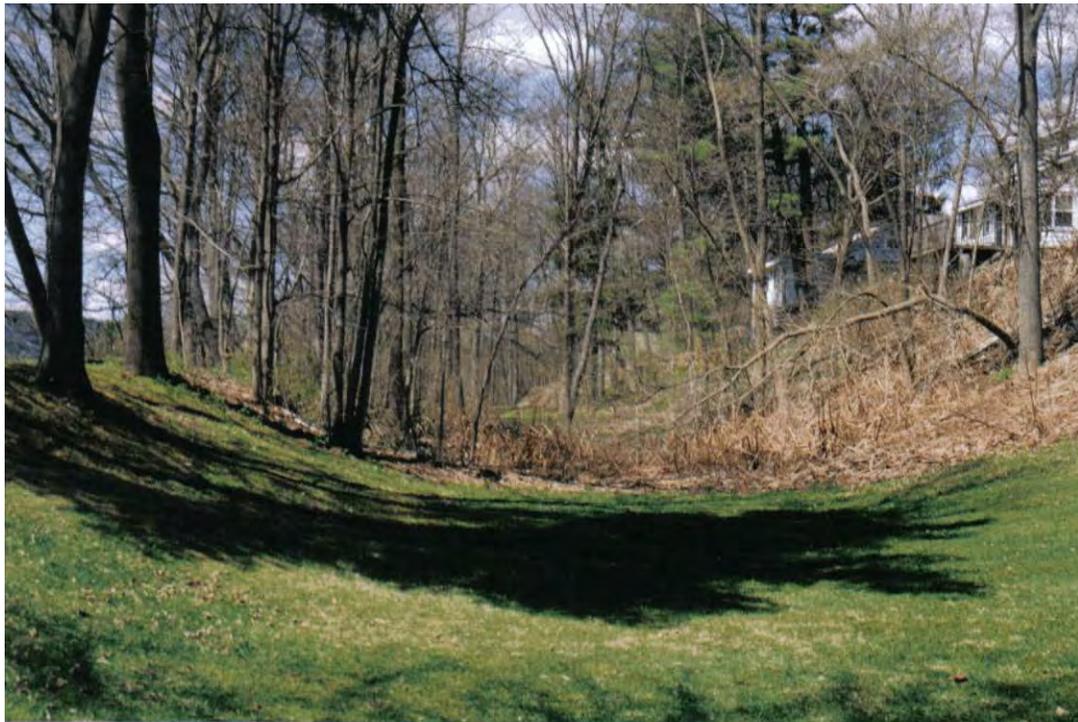
The Town of Fenton owns the canal property that parallels Pleasant Valley Road. The tow path is adjacent to the river and the prism is cut into the base of the hill.

Above - looking north along the tow path. Below - the mowed prism.

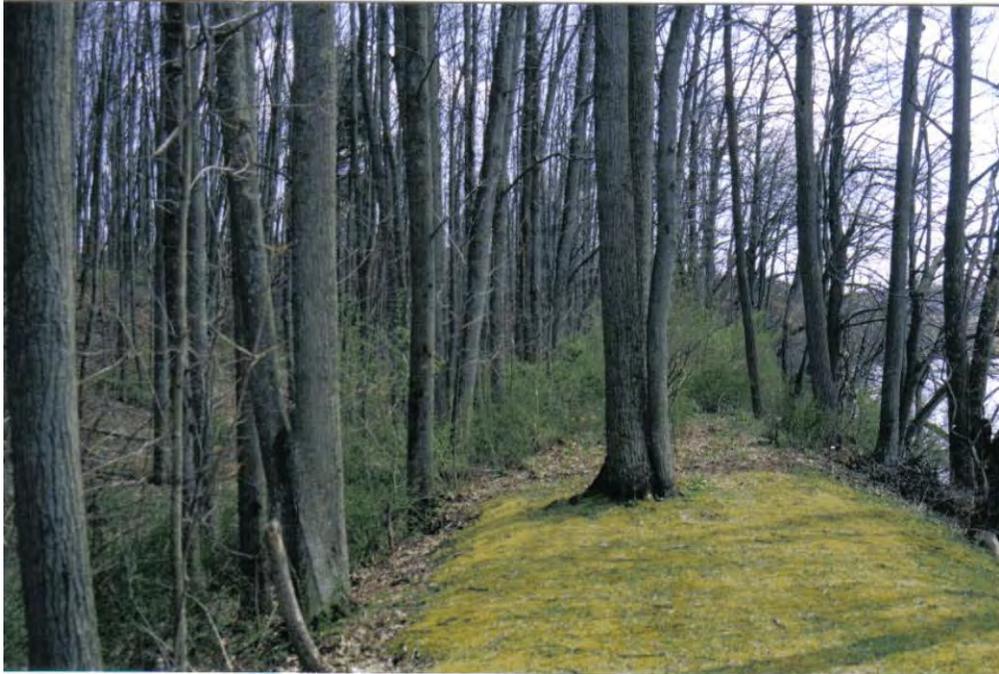
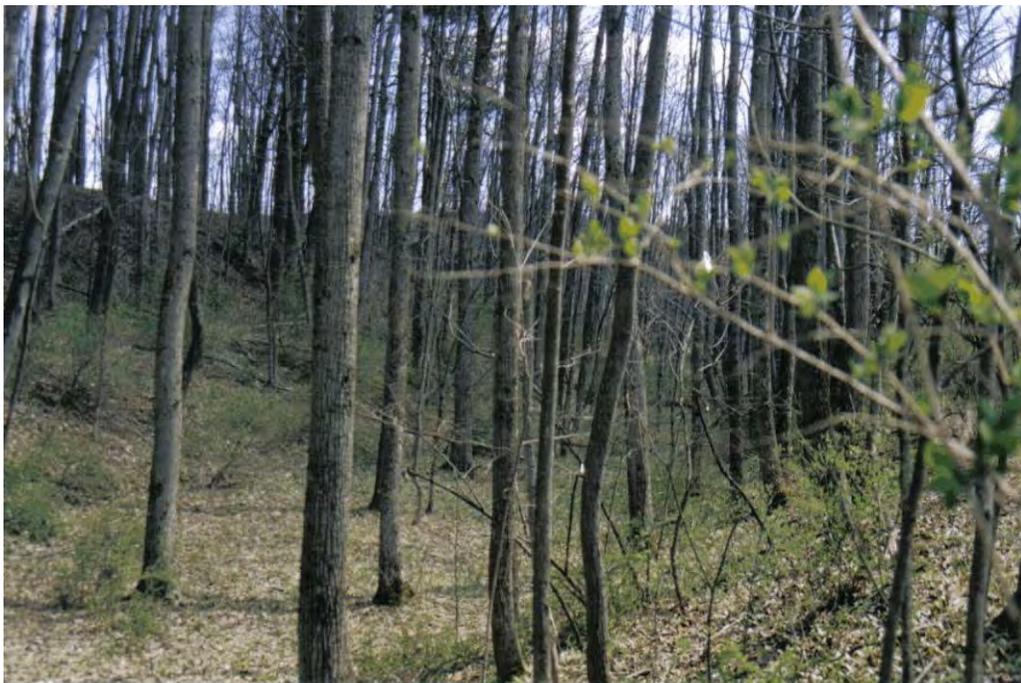
As it curves away from the river around the base of a knoll, the canal remnants again cross private land. The prism and tow path are intact although covered in brush.

Above - looking south along the tow path into private property.
Below - looking into the prism

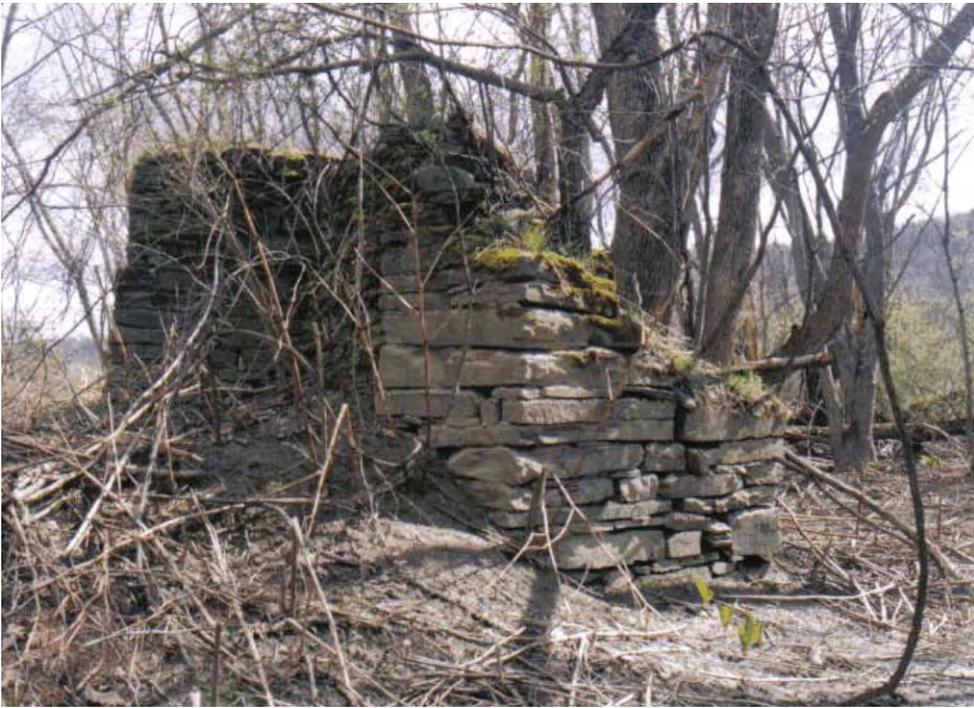
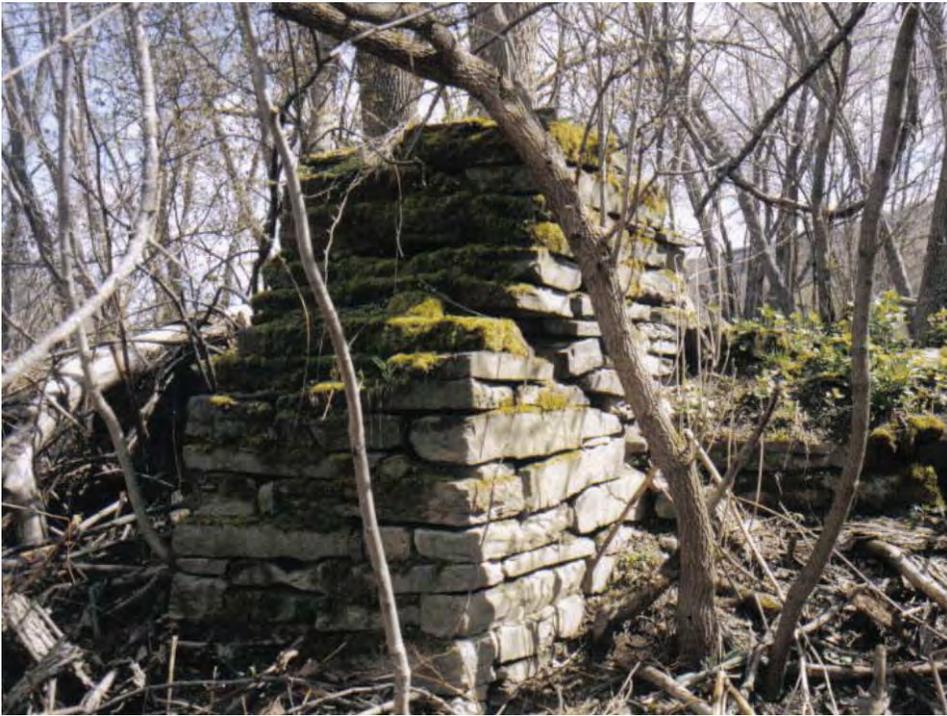
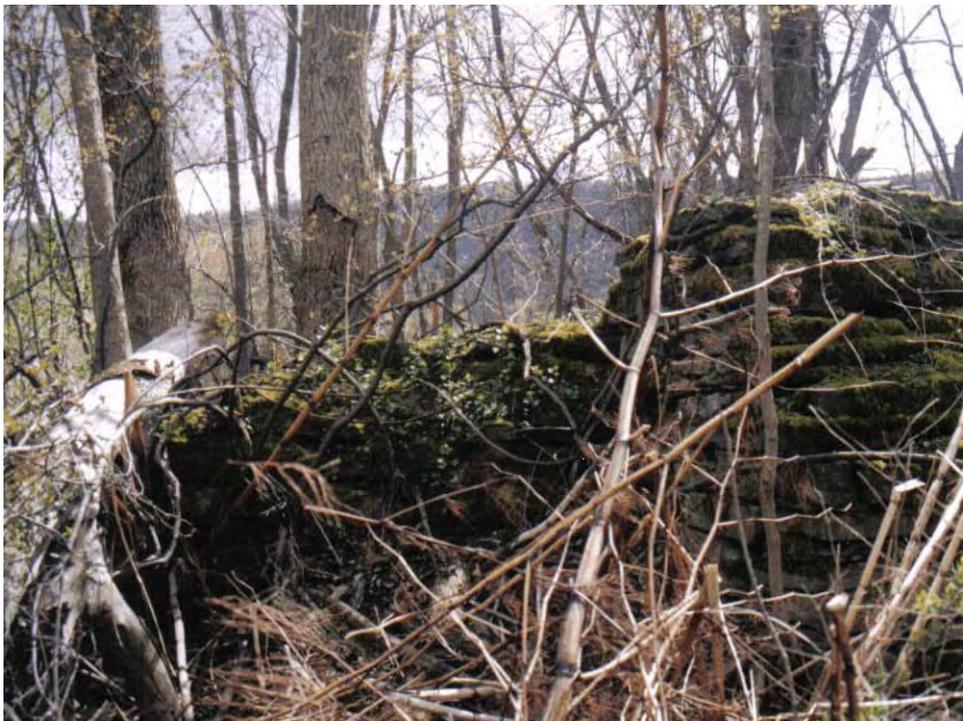
Details of the east abutment

Above and below - the west abutment.
The west abutment is not as well preserved as the east.

The only other extant canal feature of note, the remains of the Page Brook aqueduct, would be difficult to interpret given its location. The canal prism is no longer present on either side of the piers and the brook has changed course so that it no longer flows between them. Lacking context, its interpretative value is limited and its location, on private property far from the road, adds to the difficulty in utilizing the site for educational purposes.

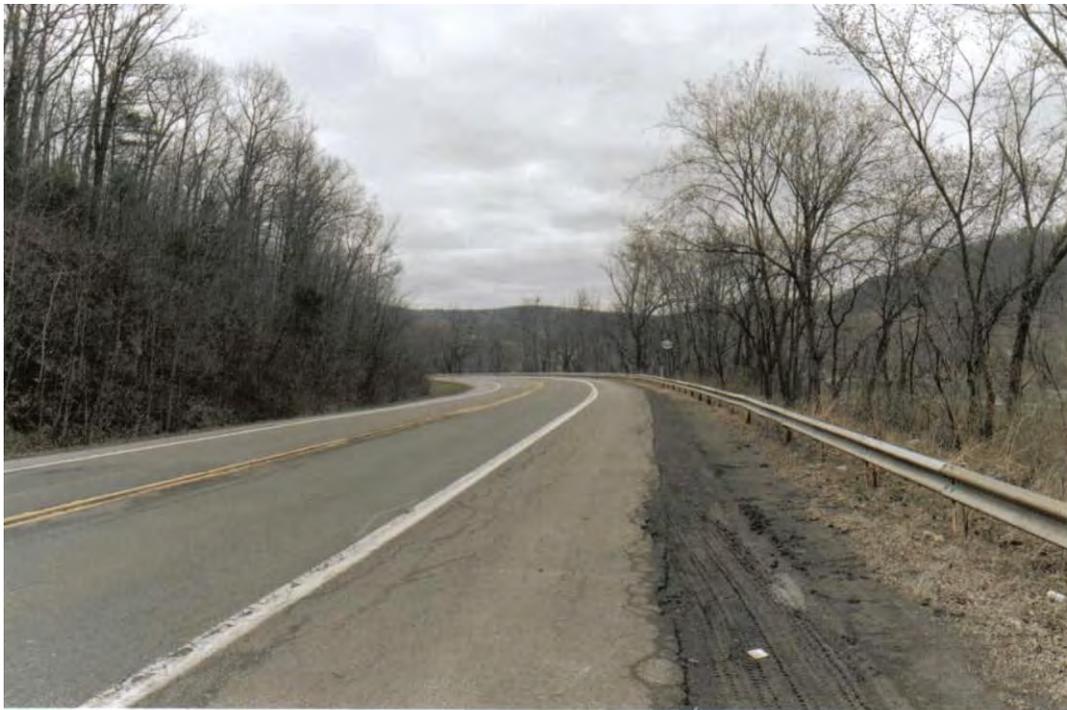
The northeast corner of this lot was the west side of the tow path and the eastern edge of the property follows the tow path. The Chenango River has eroded the tow path at the southern end of the property. The canal followed the route of Route 369 from this property to the Village of Port Crane.

Looking south - the canal prism was located between the base of the hill and the river.
Route 369 has replaced the canal in this location.

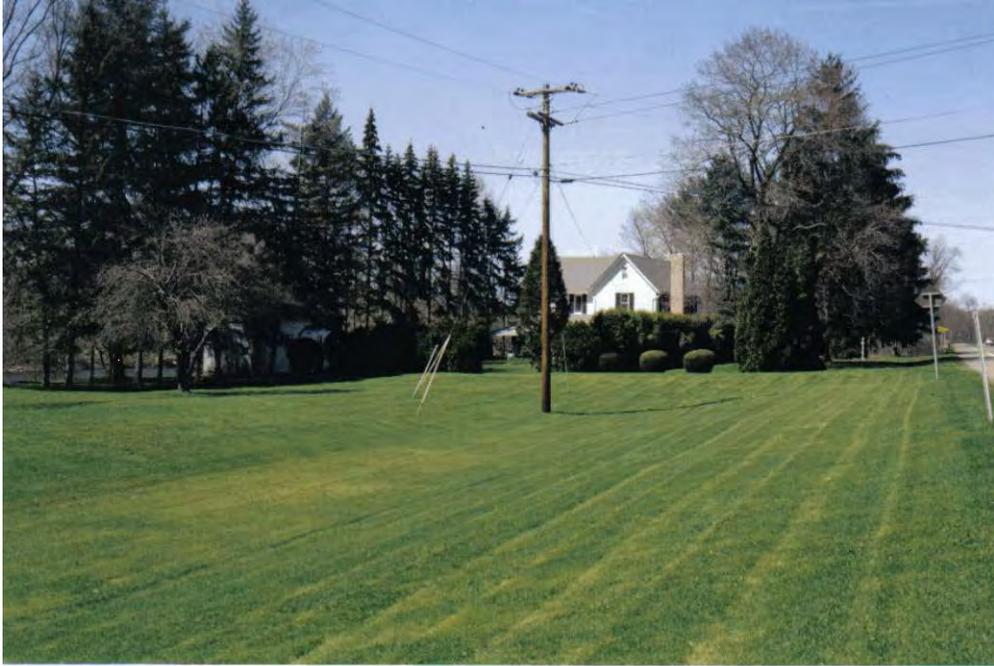
The swale of the canal prism is visible in the yard of this property on the west side of Route 369.

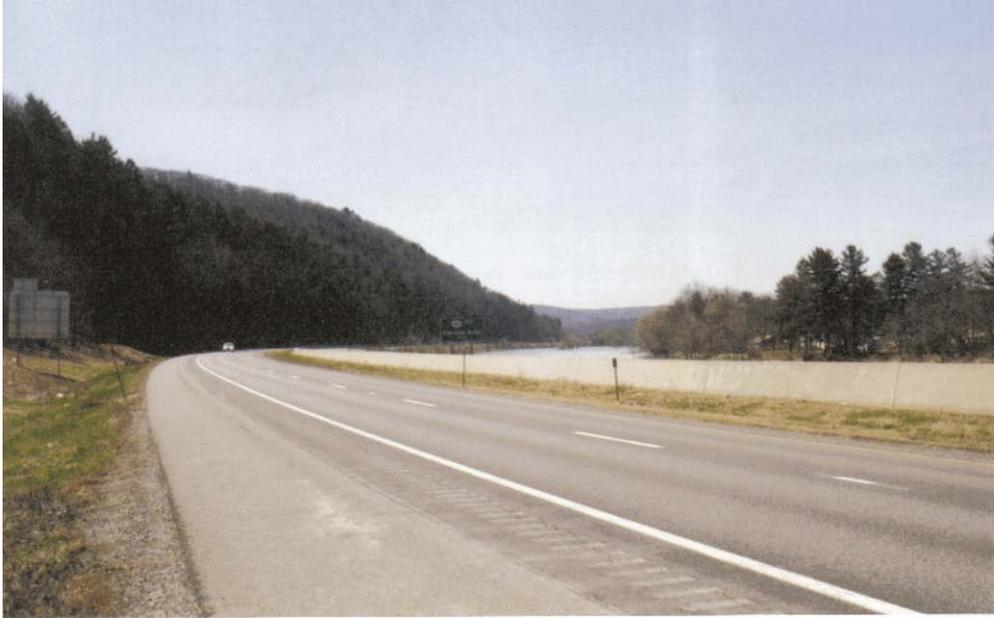
Looking south along Route 88 toward Chenango Forks. The canal followed this path.

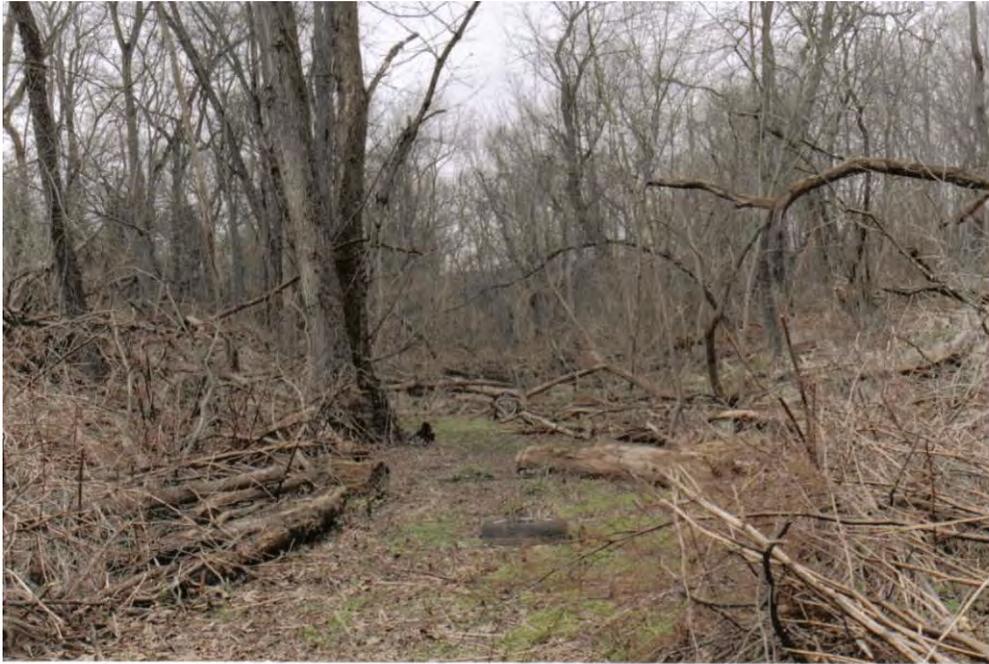
Remnants of the canal are again visible at the base of the hill below Dale Court and Ivan Lane. The canal made a sweeping curve around the base of the hill. The prism is choked with weeds and underbrush, but it is still evident.

Standing in the prism looking north. The tow path is on the left.

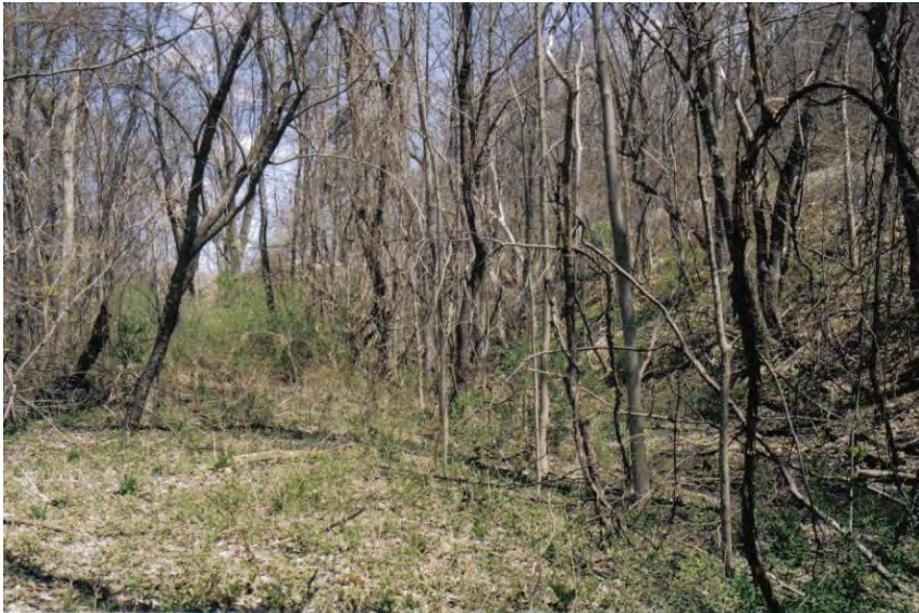
128.60 - 3- 4

The prism, although overgrown, is visible along the western property line.

This photo, looking north, shows the berm of the canal with the railroad bed visible at the upper right side of the photograph.

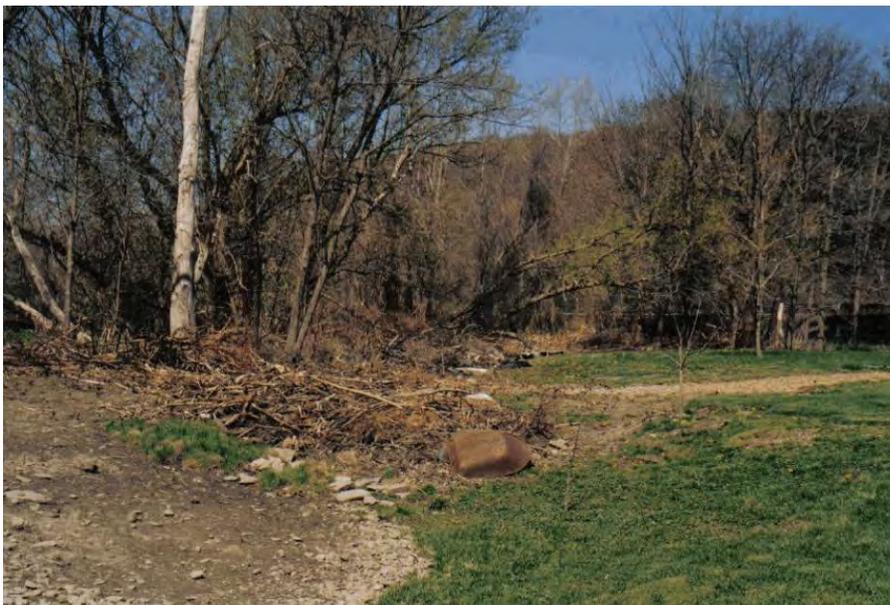
The canal gently curved to the west again crossing the Brandywine Highway. The canal formed the rear property lines of three properties facing Old State Road on the north side of the road. The property owners have been working to fill the prism and smooth out the contours found in their yards.

19 Old State Road - looking northeast from the backyard the, towpath is on the left. Debris fills the remains of the prism.
